Figure 2-1 is a 1998 aerial photograph of the Avon-Buxton segment of the Outer Banks showing the location of the Sea-View site. Figure 2-2A is a 1992 oblique aerial view and figure 2-2B is a 1999 aerial photograph of the Avon-Buxton site on Hatteras Island. These figures demonstrate how narrow the Avon-to-Buxton coastal segment is. It is a classic overwash barrier island that is basically sediment poor (relatively small quantity of available sand) and has the highest wave energy along the U.S. Atlantic coast. Consequently, the beach tends to be narrow and steep with coarse gravelly sand sediment (see table 2-1 in the lesson “Making a cross island topographic profile”).

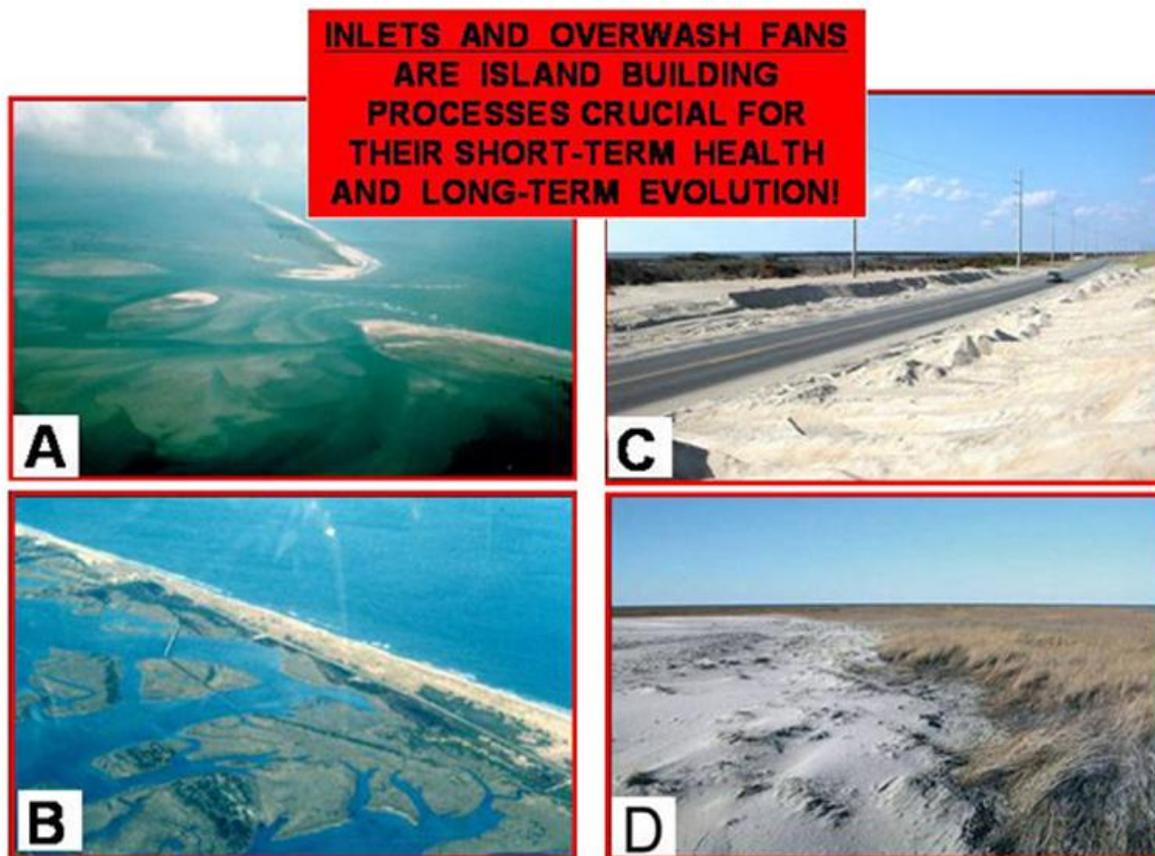
**Figure 2-4.** Inlets and overwash fans are critical barrier island building processes that are crucial for their short-term health and long-term evolution. **Panel A** is an oblique aerial photo of the active New Drum Inlet on Core Banks with a major flood-tide delta formed on the backside of the barrier. Photo is by D. Heron. **Panel B** is a 1992 oblique aerial photo of New Inlet on Pea Island that was closed naturally in 1945 and shows the extensive salt marsh that has grown on the shallow sand shoals of the flood-tide delta since the inlet closed. Photo is by S. Riggs. **Panels C and D** are 2003 ground photos of major overwash fans that took place during Hurricane Isabel. In Panel C, storm overwash carried sand over the island just south of the Sea-View site and deposited ~2 feet of sand across N.C. Hwy. 12 and into the adjacent shrub-scrub zone. In Panel D, storm overwash carried sand across the island and deposited up to three feet of sand in marsh. Because of the increased elevation in the marsh, the area will revegetate as shrub-scrub. Photos are by S. Riggs.

On narrow sediment-poor barrier islands such as the Avon-Buxton segment, two basic processes are critical for both the short-term health and the long-term evolution of the barrier island: inlet formation and island overwash (figure 2-4). These processes are crucial for building island elevation and width in a rising sea level situation, as presently exists in the coastal region of northeastern North Carolina. As sea level rises, storms erode the ocean shoreline (figure 2-3). In order for a barrier island to survive in this situation, the back barrier must receive sand that increases both the width and elevation. The addition of back-barrier sand allows the island to move upward and landward in response to ongoing sea-level rise.

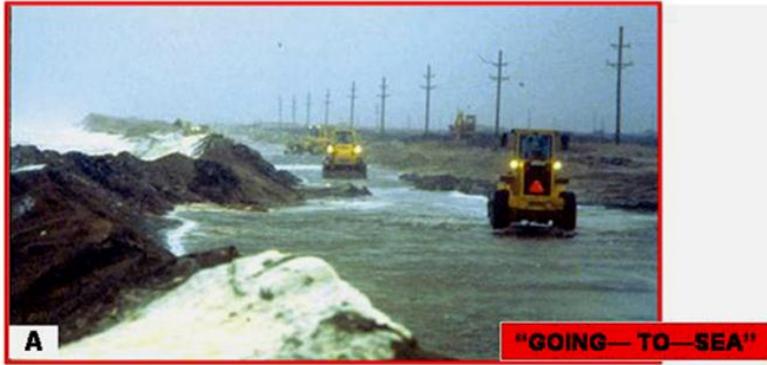
**Figure 2-12.** N.C. Hwy. 12 “going-to-sea” as the storm tide washes over the road during a typical nor’easter. In some storms the highway is just buried in overwash sand that is cleared off the road and put back into a barrier-dune ridge. Other storms physically destroy the road as it finds itself in the surf zone. Photograph A is by O.H. Pilkey, Photograph B is by S. Riggs, and Photograph C is by Cape Hatteras National Seashore personnel.

Starting in the late 1930s, North Carolina began a program of building barrier-dune ridges along the shoreline from the Virginia line south to Ocracoke Inlet (figure 2-10A-B). Barrier-dune ridge construction became the dominant policy for protecting N.C. Highway 12 after it was a paved road down the Outer Banks in the late 1950s and early 1960s. However, barrier-dune ridges, which act as a temporary fort wall to keep the ocean out, are totally out of equilibrium on the Outer Banks barrier islands and extremely vulnerable to ongoing coastal erosion (figure 2-10C-D). As soon as the dune ridges are constructed, they are attacked by ocean storm waves, become severely scarpred, and are quickly breached (figure 2011). If the barrier-dune ridges that are protecting N.C. Highway 12 are breached, the overwash through the breach will either bury the highway with sand or take the highway out completely (figure 2-12).
