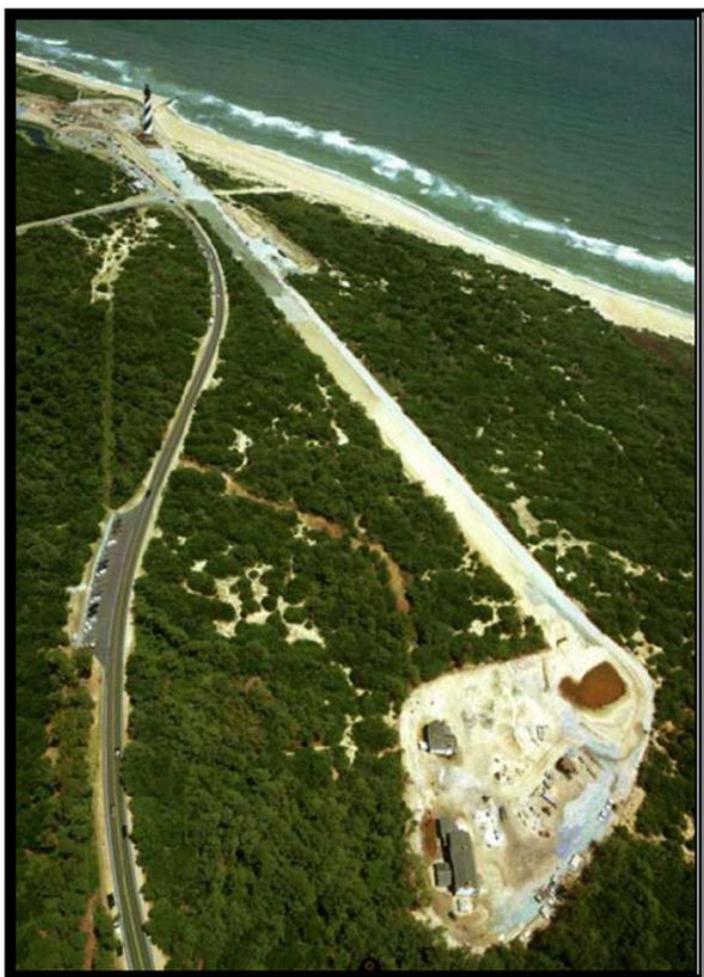
Figure 1-33. Cape Hatteras Lighthouse is being prepared for its move from the old threatened site adjacent to the rapidly eroding shoreline to a new inland site. Photograph is by the N.C. Department of Transportation.

The decision was made by the U.S. National Park Service and Cape Hatteras National Seashore to move the lighthouse in 1999 to a site inland of its original location. Figure 1-33 shows the lighthouse in its original position at the top left of the photo and a prepared roadway to the new site at the bottom right. Figure 1-34 shows the lighthouse in route to its new location further inland from the ocean.

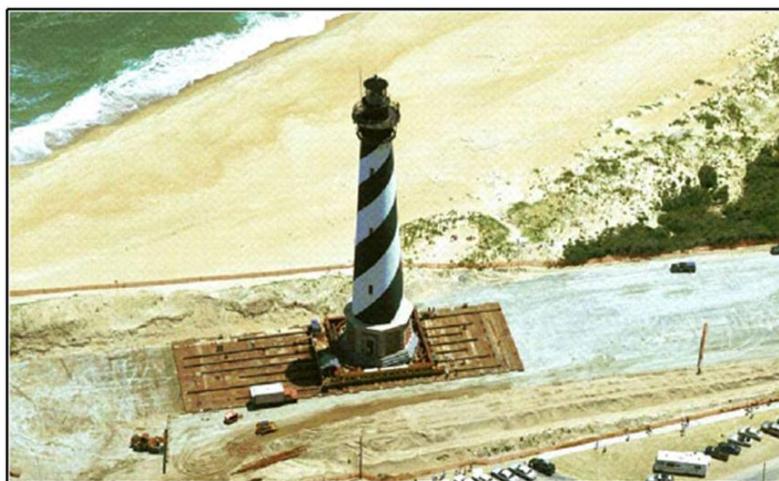
Figure 1-34. Cape Hatteras Lighthouse is on its slow and deliberate move towards the new inland relocation site. Photograph is by the N.C. Department of Transportation.

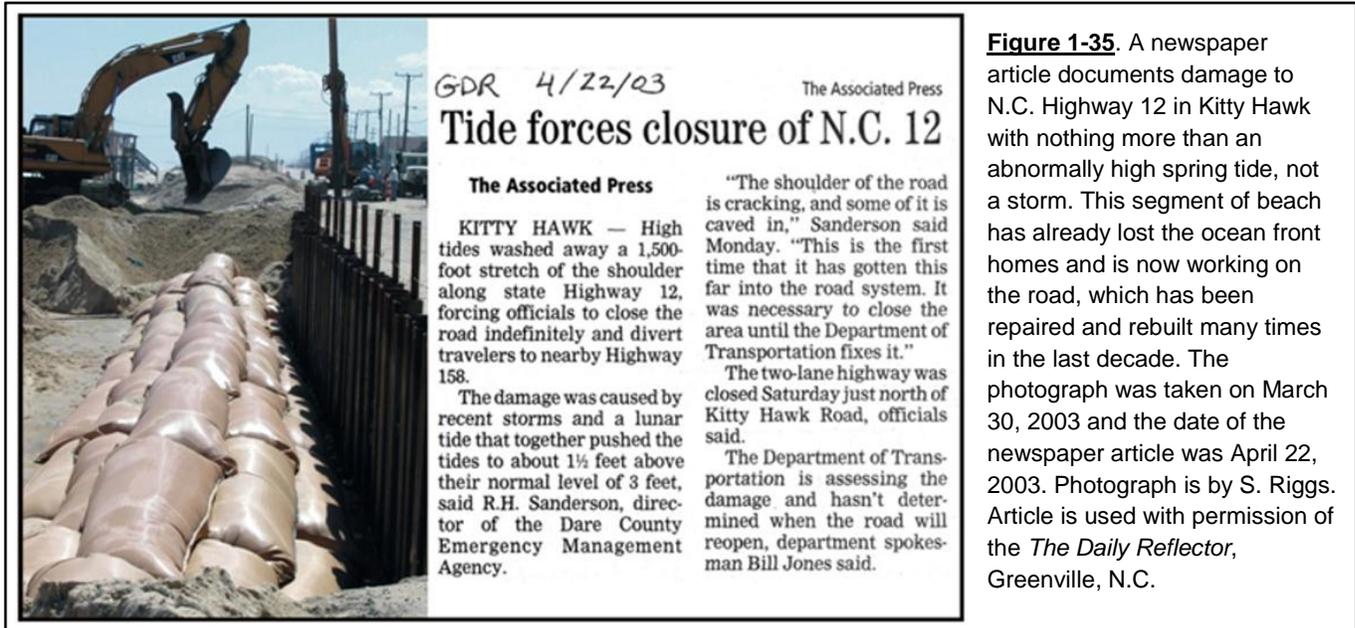
Figure 1-35. A newspaper article documents damage to N.C. Highway 12 in Kitty Hawk with nothing more than an abnormally high spring tide, not a storm. This segment of beach has already lost the ocean front homes and is now working on the road, which has been repaired and rebuilt many times in the last decade. The photograph was taken on March 30, 2003 and the date of the newspaper article was April 22, 2003. Photograph is by S. Riggs. Article is used with permission of the *The Daily Reflector*, Greenville, N.C.

The conflict continues between the natural processes of sea-level rise and coastal storms, causing the ocean to continue its erosional transgression on human infrastructure and houses. Figure 1-35 shows the N.C. Department of Transportation shoring up N.C. Highway 12 in Kitty Hawk. The photograph was taken on March 30, 2003 and the date of the newspaper article was April 22, 2003. It was not even a storm that took out this segment of N.C. Highway 12 but just an abnormally high spring tide.

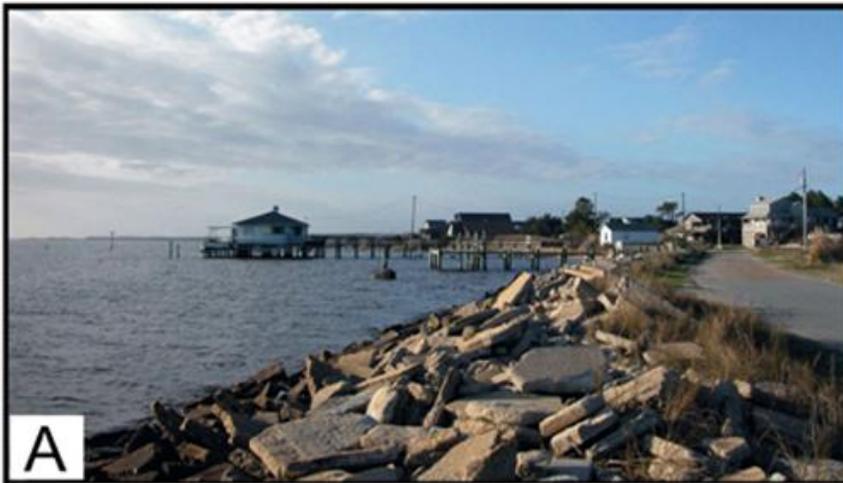
Figure 1-36. Hardened structures along the sediment-bank shorelines within the estuarine system were built in an effort to stabilize the rapidly eroding shoreline. Notice that there are no sand beaches in front of most stabilized estuarine shorelines.

Panel A: Concrete rip-rap has been dumped multiple times along Sound Side Road on the back side of the barrier island at Nags Head.

As ever-increasing numbers of people and businesses move to the coastal region and more and more hotels, restaurants, and beach houses are built, decision makers have used many methods to deal with the problems of shifting shorelines. In some cases, they have chosen hard structures that were considered to be permanent solutions to coastal erosion. On the ocean shoreline, hardened structures such as those used around the Cape Hatteras Lighthouse (figure 1-32) were no longer allowed by the mid-1980s. However, no such rules have been put in place for the estuarine shoreline. This has resulted in the extensive use of hardened structures associated with most development (figure 1-36).

Rock revetments, bulkheads, and other forms of shoreline hardening on eroding sediment-banks cut off the internal sand supply, and beach sands soon begin to disappear. The hardening of one piece of property along a shoreline will generally increase the rates of erosion on adjacent properties. This is the domino effect that usually forces the neighbors to begin hardening their shoreline, accelerating the rate of beach loss. Hardened shorelines will lose their sandy beach completely (figure 1-36) unless their neighbors allow the adjacent shorelines to continue to erode.

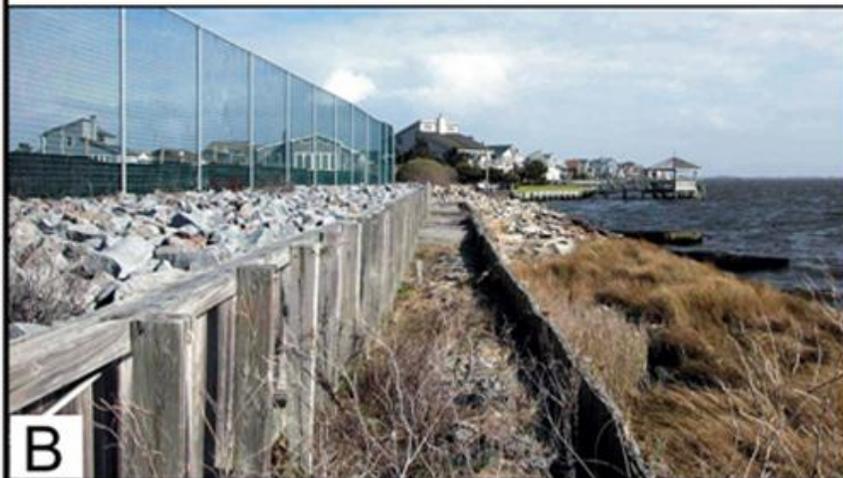
Panel B: Multiple layers of wooden groins, wooden bulkheads, and rock revetments have been emplaced to protect the tennis courts on the back side of the barrier island at Nags Head Cove.

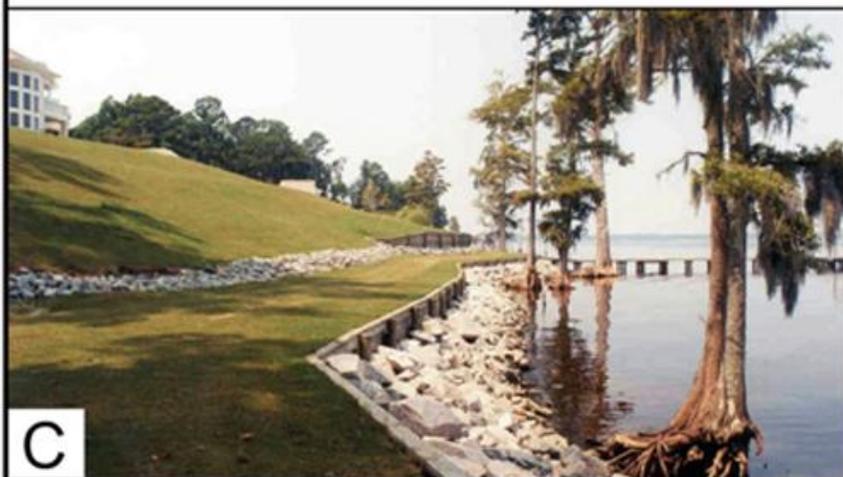
Panel C: The sediment bluff was terraced; steel bulkheads and rock rip-rap were emplaced along the shoreline at Maults Point in the Pamlico River estuary. All photographs are by S. Riggs.
